SUBJECT John Anglin, Clarence Anglin and
Frank Lee Morris Escape from Alcatraz

FILE NUMBER 76-26295

VOLUME NUMBER Enclosures 76, 137, 155 and 179

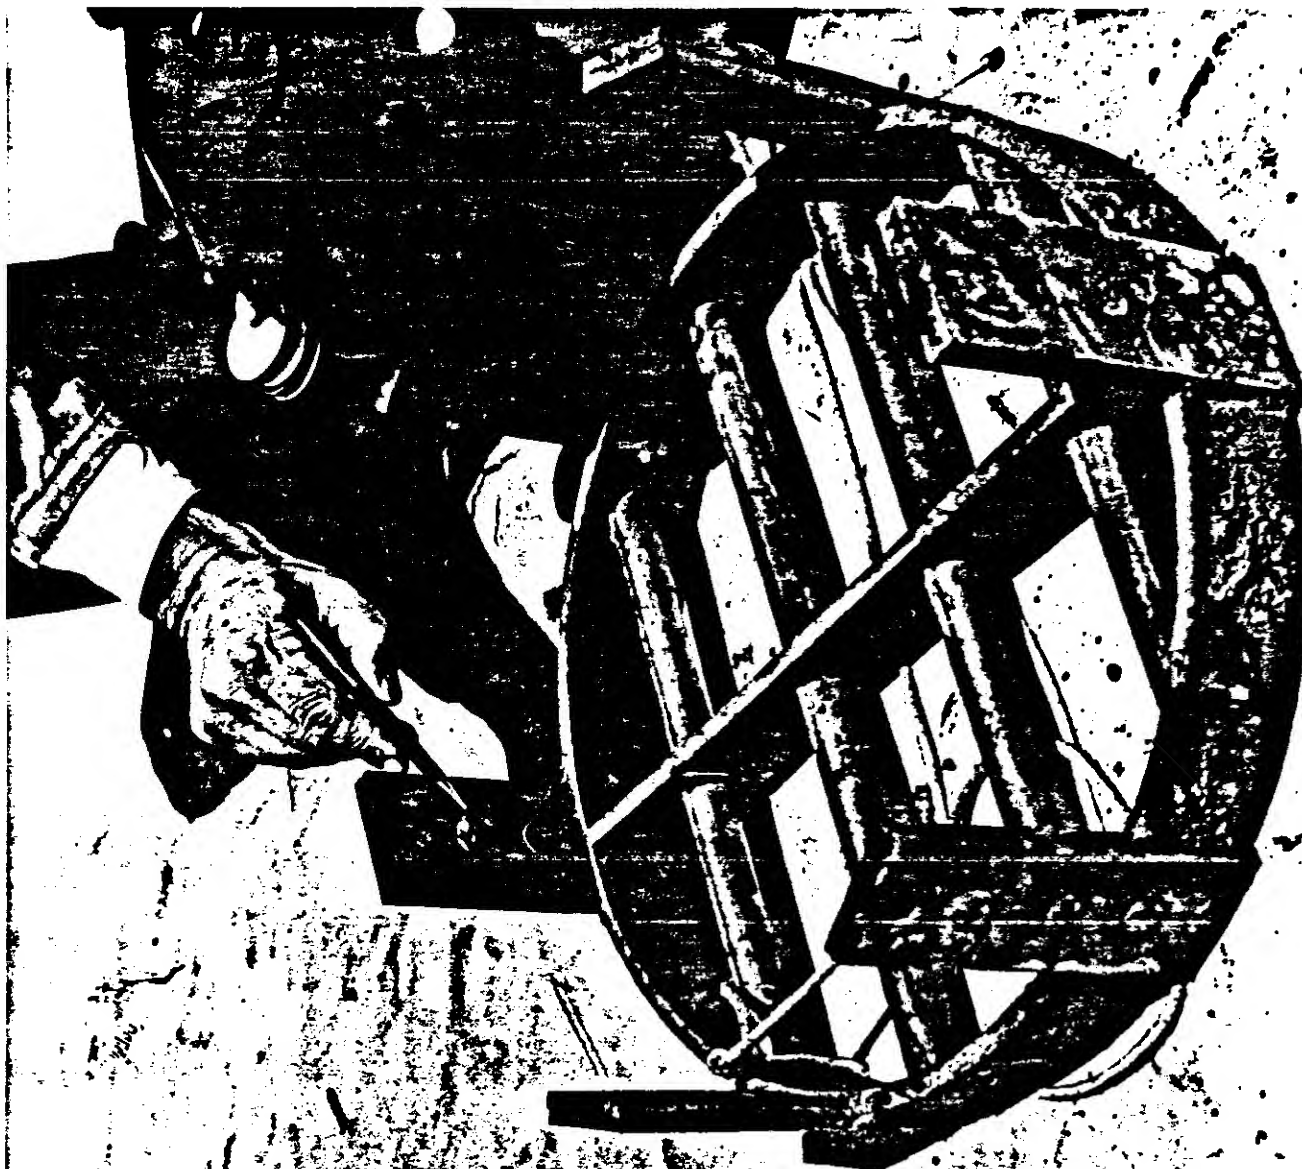
1-3 Same as 1-2 with the exception that pencil is used to point out the bolt head made of soap which is one of two found on the roof.

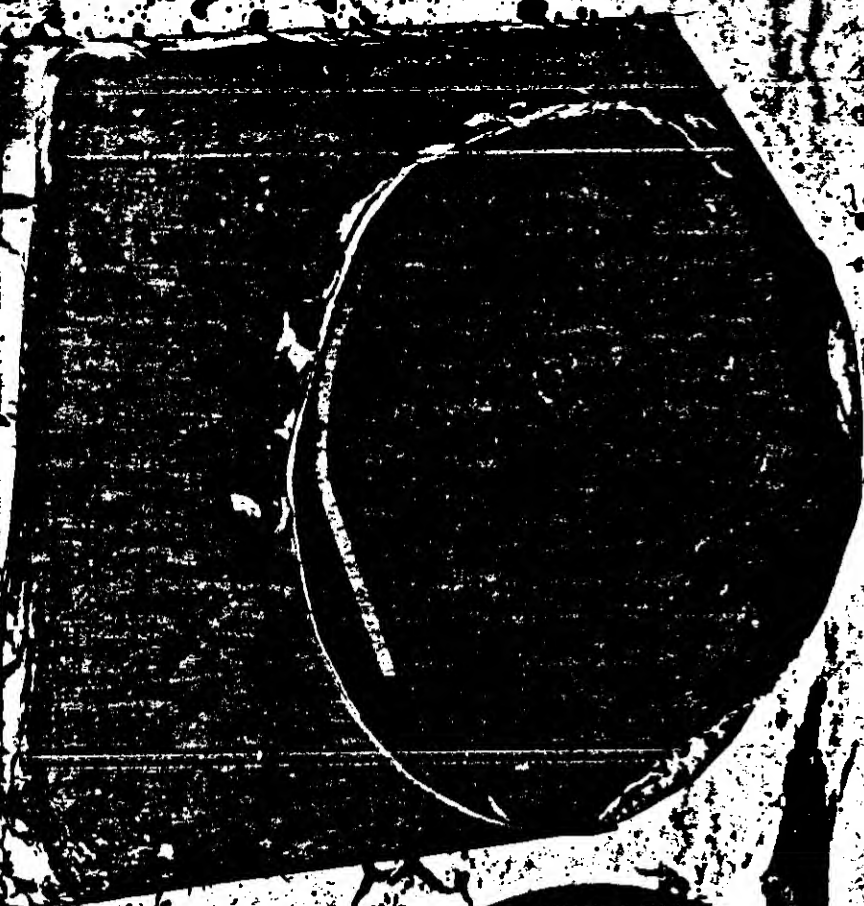
1-4 Photo taken by photographer standing on pipe vent shown in 1-1 looking into the galvanized vent leading into space over Cell Block B. Photo taken in an eastern direction and shows one of the two re-enforcing rods which obstructed this hole and was bent to permit egress.

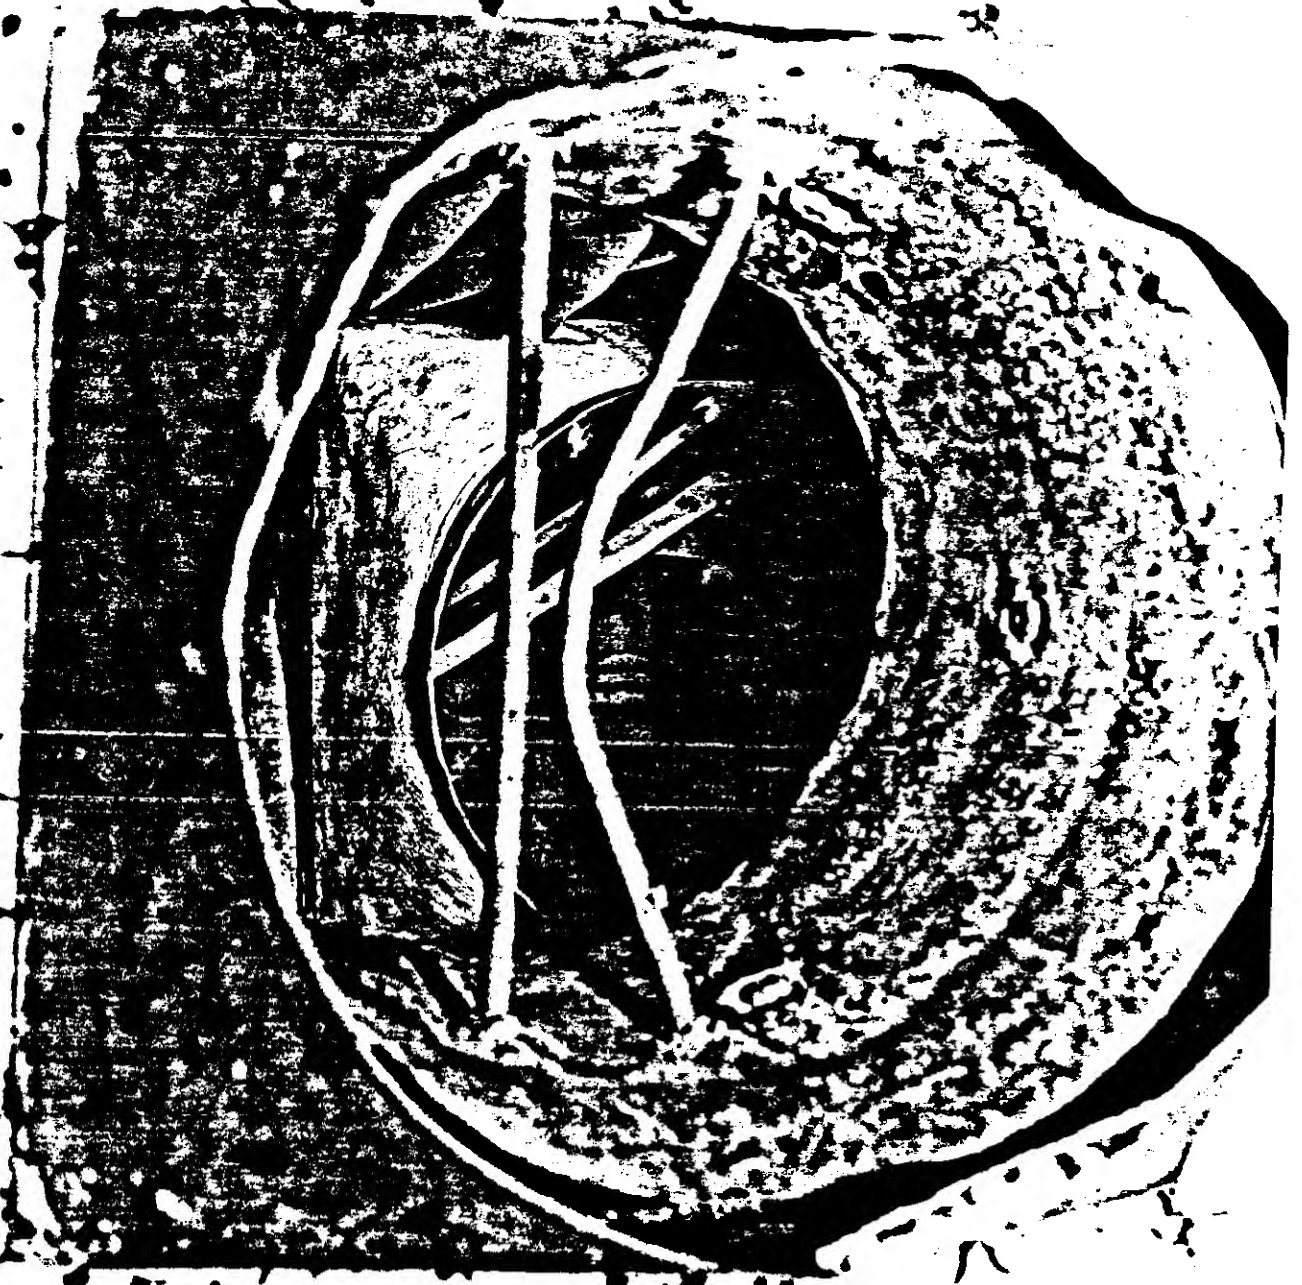
1-8 This photograph was taken directly over the ventilator opening on the roof and shows the vent re-enforcing rod and the stud holes normally used to fasten down the heavy galvanized grate shown in photographs 1-1, 2, and 3. Immediately below the opening may be seen the top of the motor housing which is normally offset from the roof opening and when in operation is joined by a galvanized gooseneck connection. The blades of the "squirrel cage" type air impeller may be seen just above the bent portion of the re-enforcing rod. The bent rod is on the eastern side of the hole.

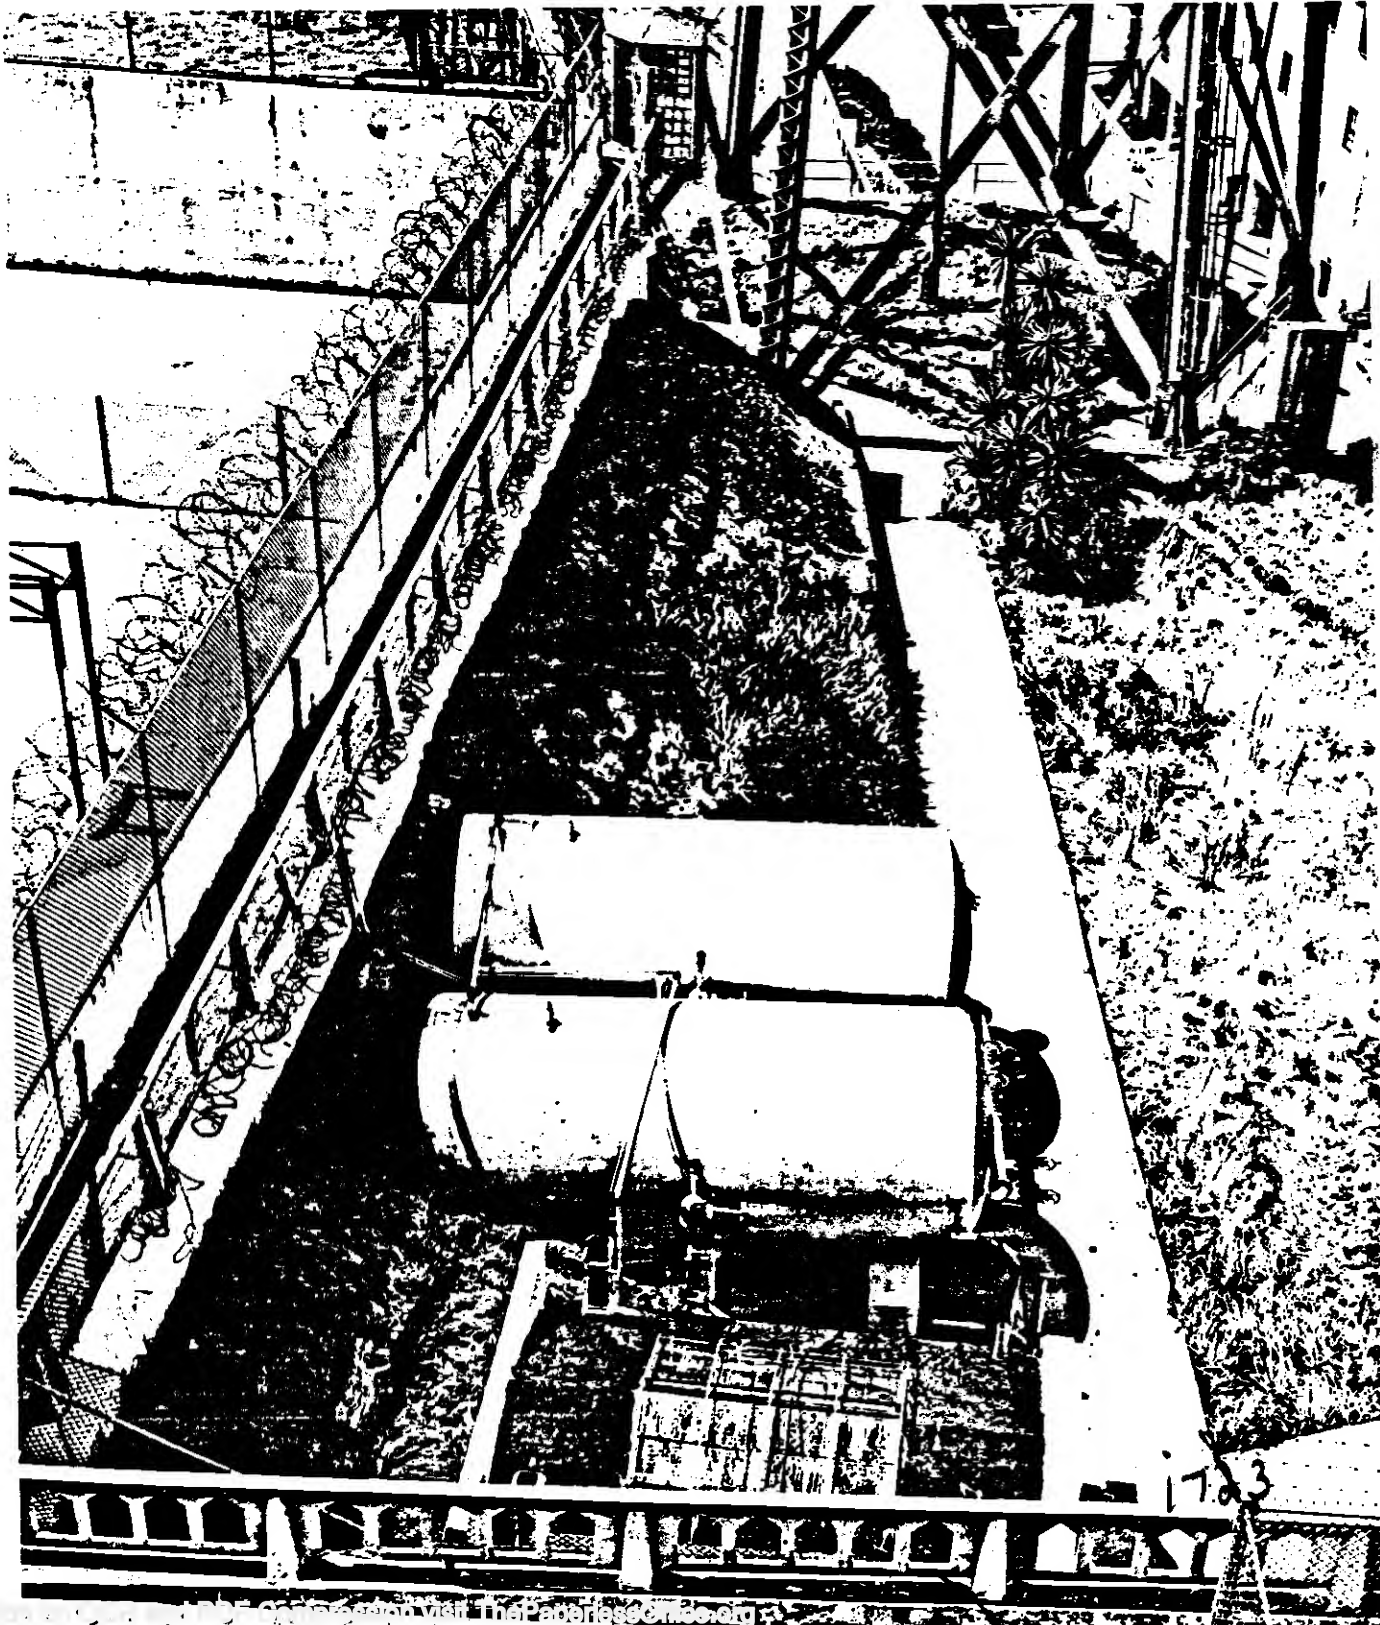
2-1 Photograph taken from top of prison building looking in a northern direction. The concrete decorative wall shown at bottom of photograph is the same as appearing at the top of 1-12. The two tanks shown in the foreground are salt water tanks with the base of the water tower shown at upper right. Top center is guardhouse number 3 and is not manned during the night hours. It is noted that lower left center along the fence, which encloses the walk to guard tower number 2, the barbed wire appears to have been cut and may have been the area over which the Subjects were able to make their escape.

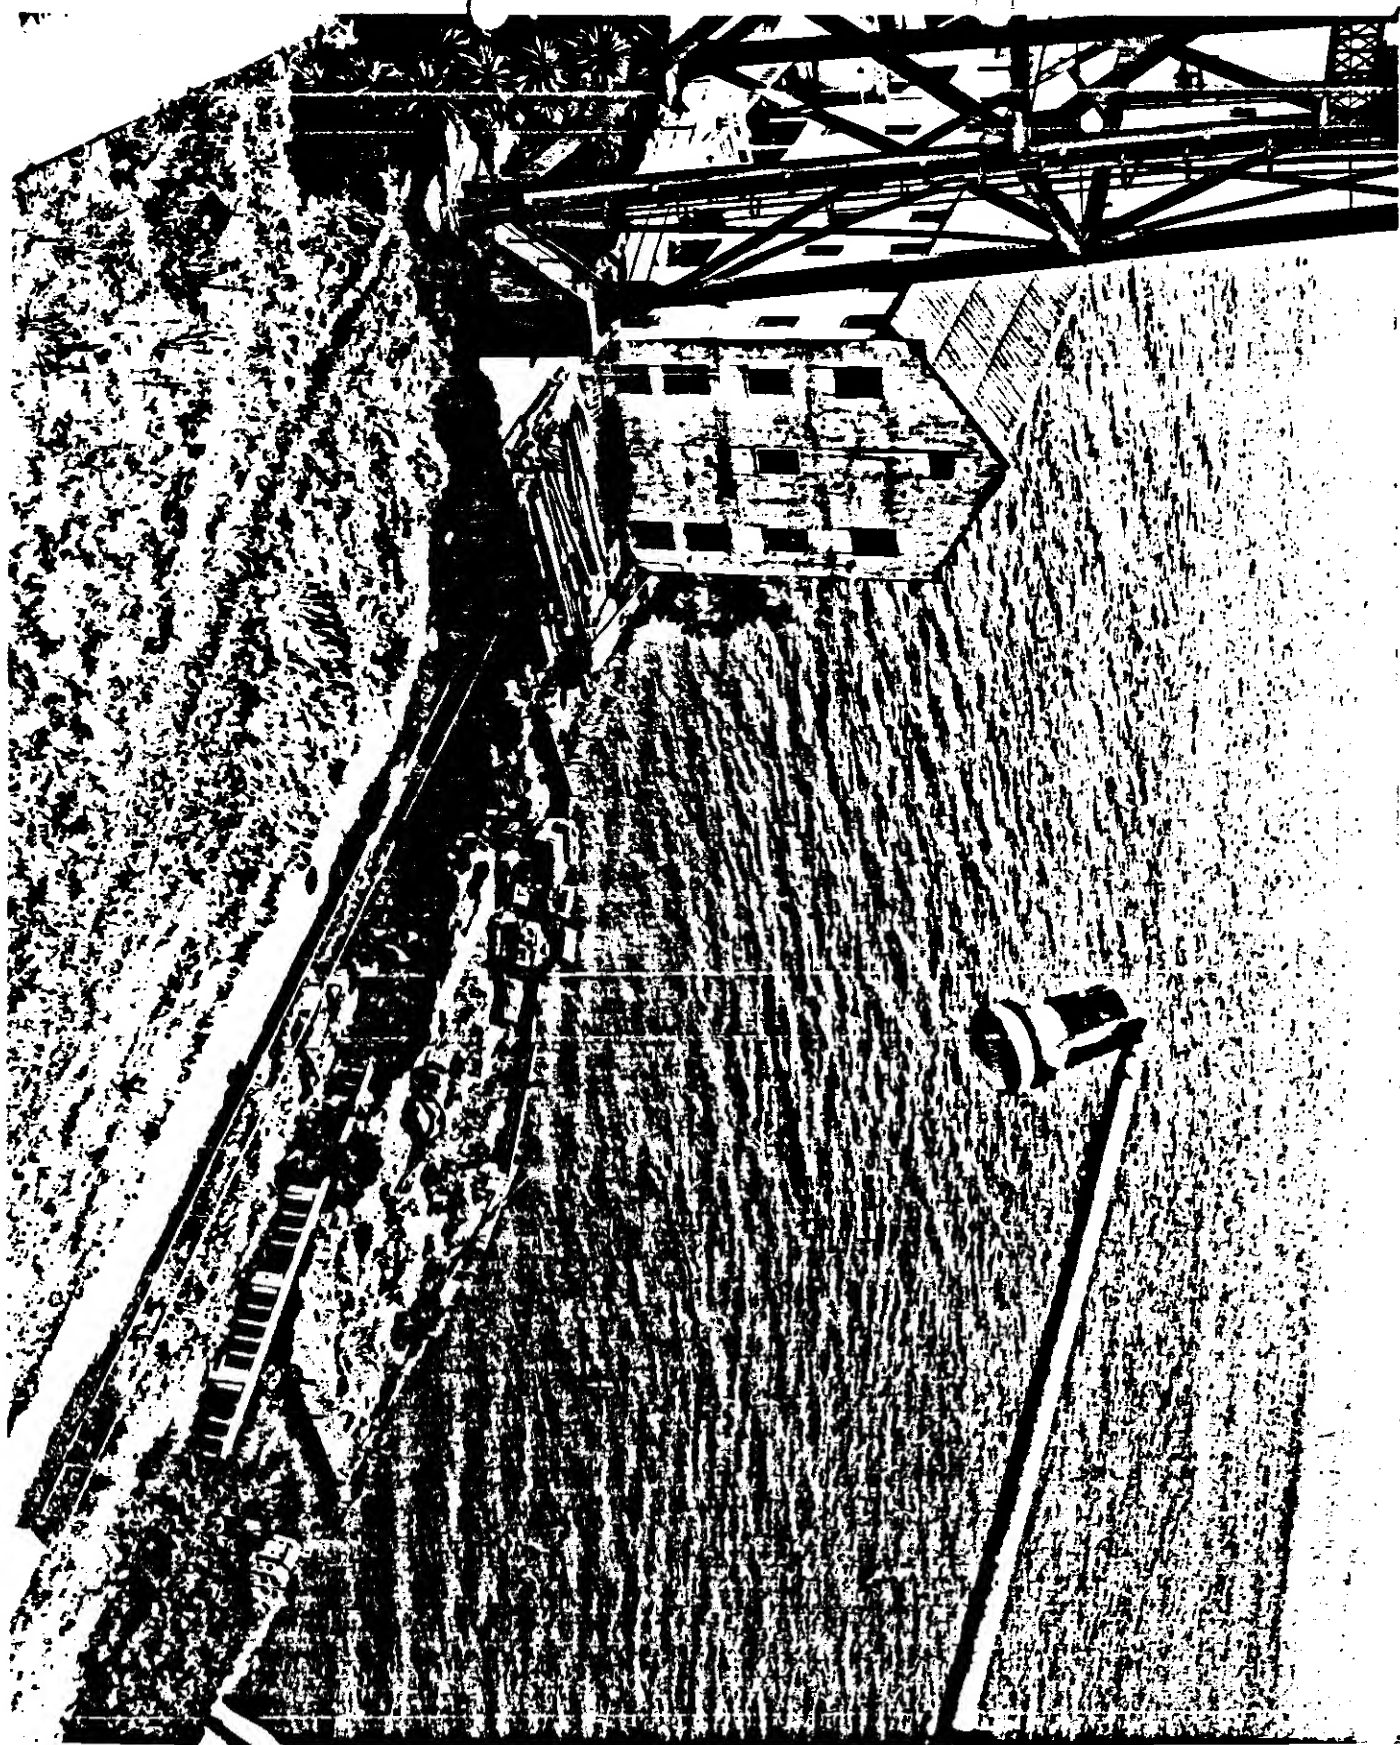
2-5

Photograph taken from roof as in preceding photograph, however this photograph shows the type of electrical fixture used to flood the sides of the building with light during the evening hours. Two such lights are spaced across the narrow or protruding end of the prison building and are spaced approximately ten to twelve feet apart. These lights receive their power from an externally mounted outlet on the inside of the edge of the roof and all connections were found to be tight and show no indications of having been tampered with. All lights were found to be in working order and were illuminated at the request of the photographer. The area at lower right is leading to the water line. It is the area believed to have been used by the Subjects in reaching the water.

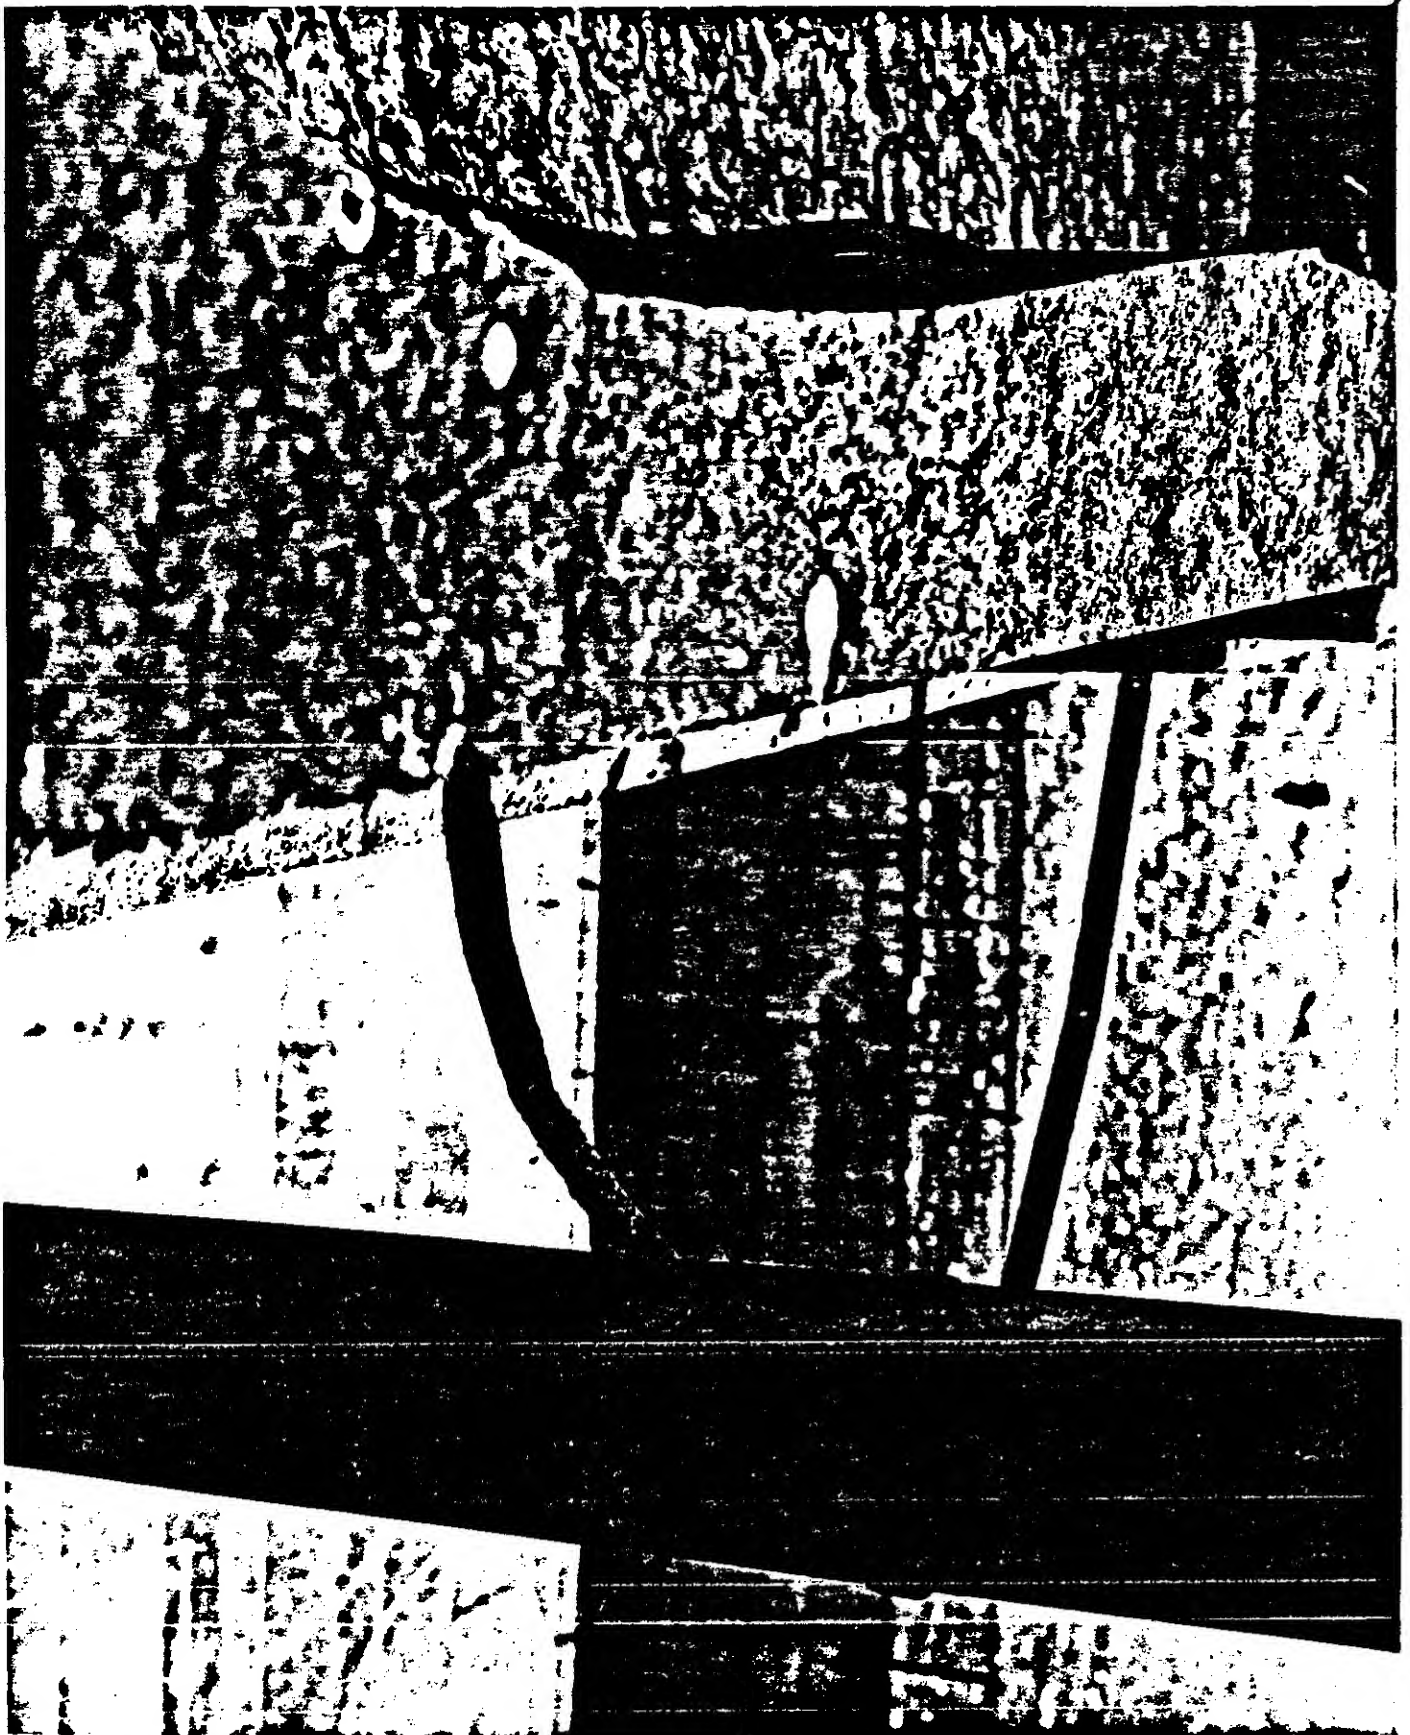
2-6 Photograph taken from top of prison building showing the edge of the building which extended approximately twenty-eight to thirty inches above the roof line. Immediately to the right will be observe angle iron brackets used to support the stack from the bake oven. This stack extends several feet above the edge of the roof and is approximately ten to twelve inches in diameter and appears to be made of cast iron.

The portion of the bracket which is visible in center foreground is noted to be bent. Prison guard [REDACTED] observed that this is a recent bend as he is quite certain this was not there the last time he observed it approximately a month ago. The stack extends to practically ground level on the exterior of the building.

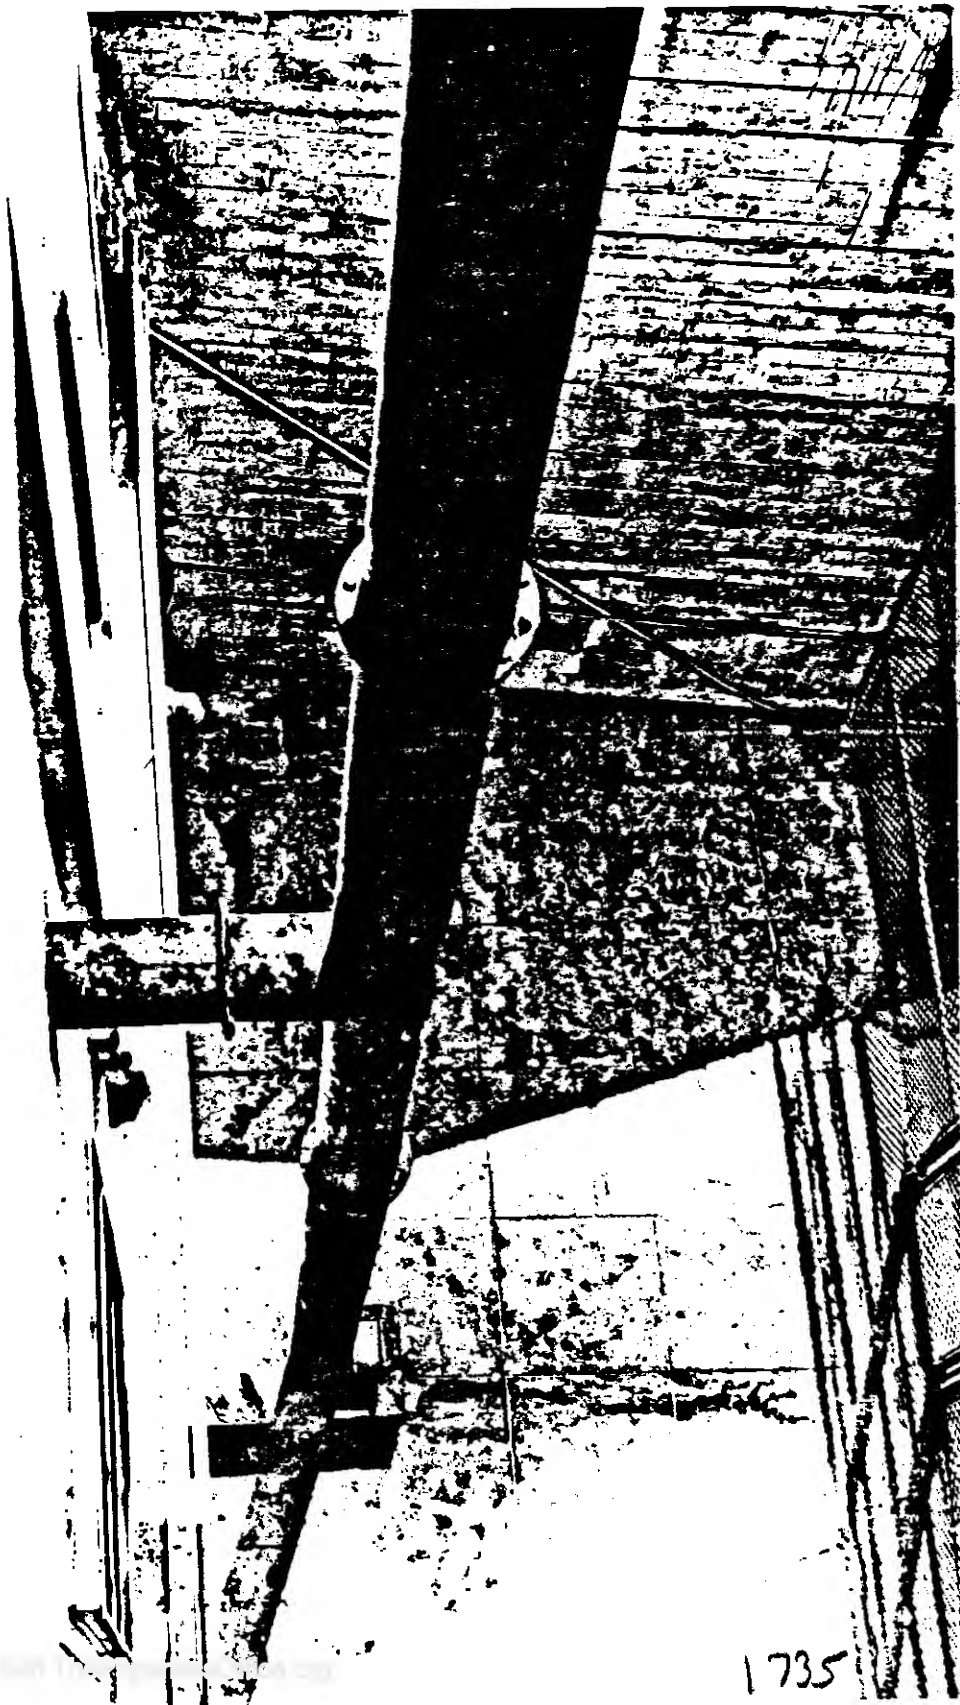
2-7 Photograph taken by leaning over the edge of the building showing the bake oven stack extending from above the roof line to the clean out on the concrete slab at ground level. The edge of the building is at left center and the distance from this to ground level is approximately forty-five feet. The wire screen topped with barbed wire seen at lower right is approximately twelve feet high.

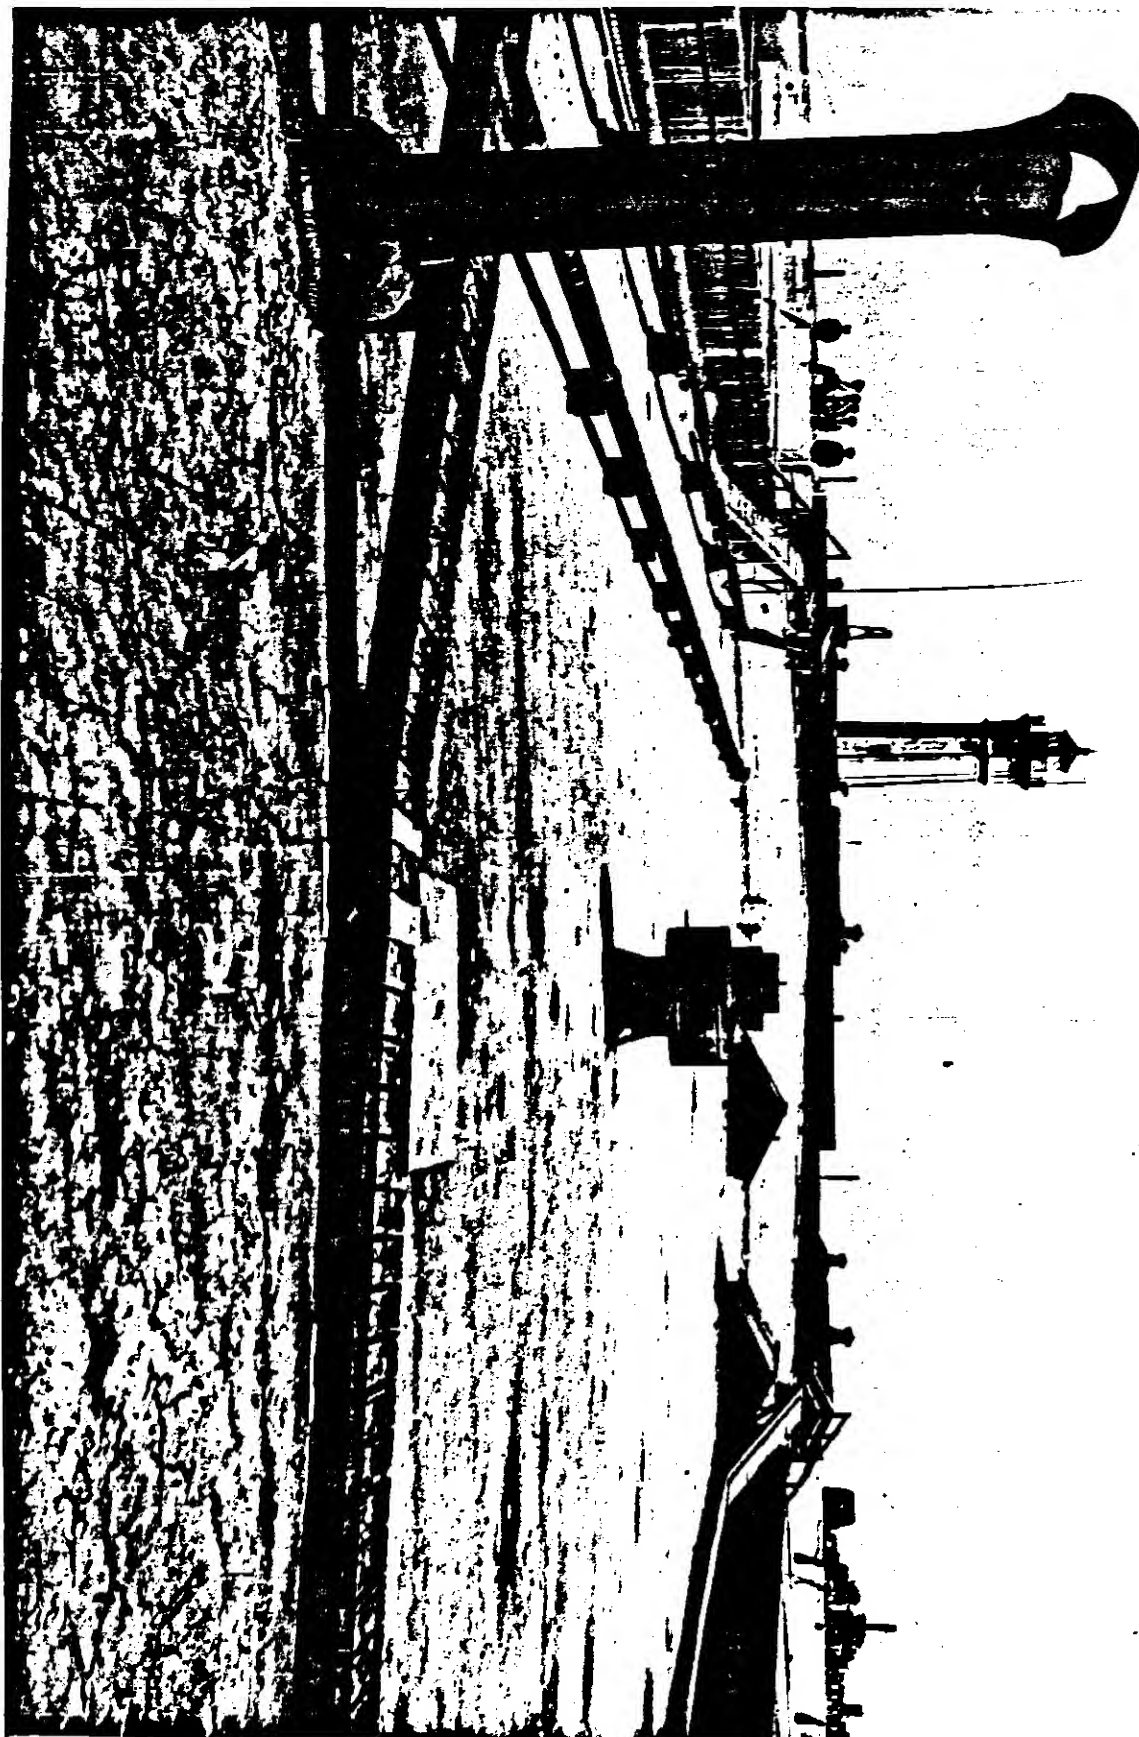
2-10 Photograph taken showing general roof area looking in a southerly direction from the bake oven stack toward the Coast Guard lighthouse. The change in the roof elevation from Cell Block A, B, and C, etc., may be observed with catwalks running on both sides of the picture. A paddle was found under the catwalk in approximate location indicated by the individuals seen in the photograph left center.

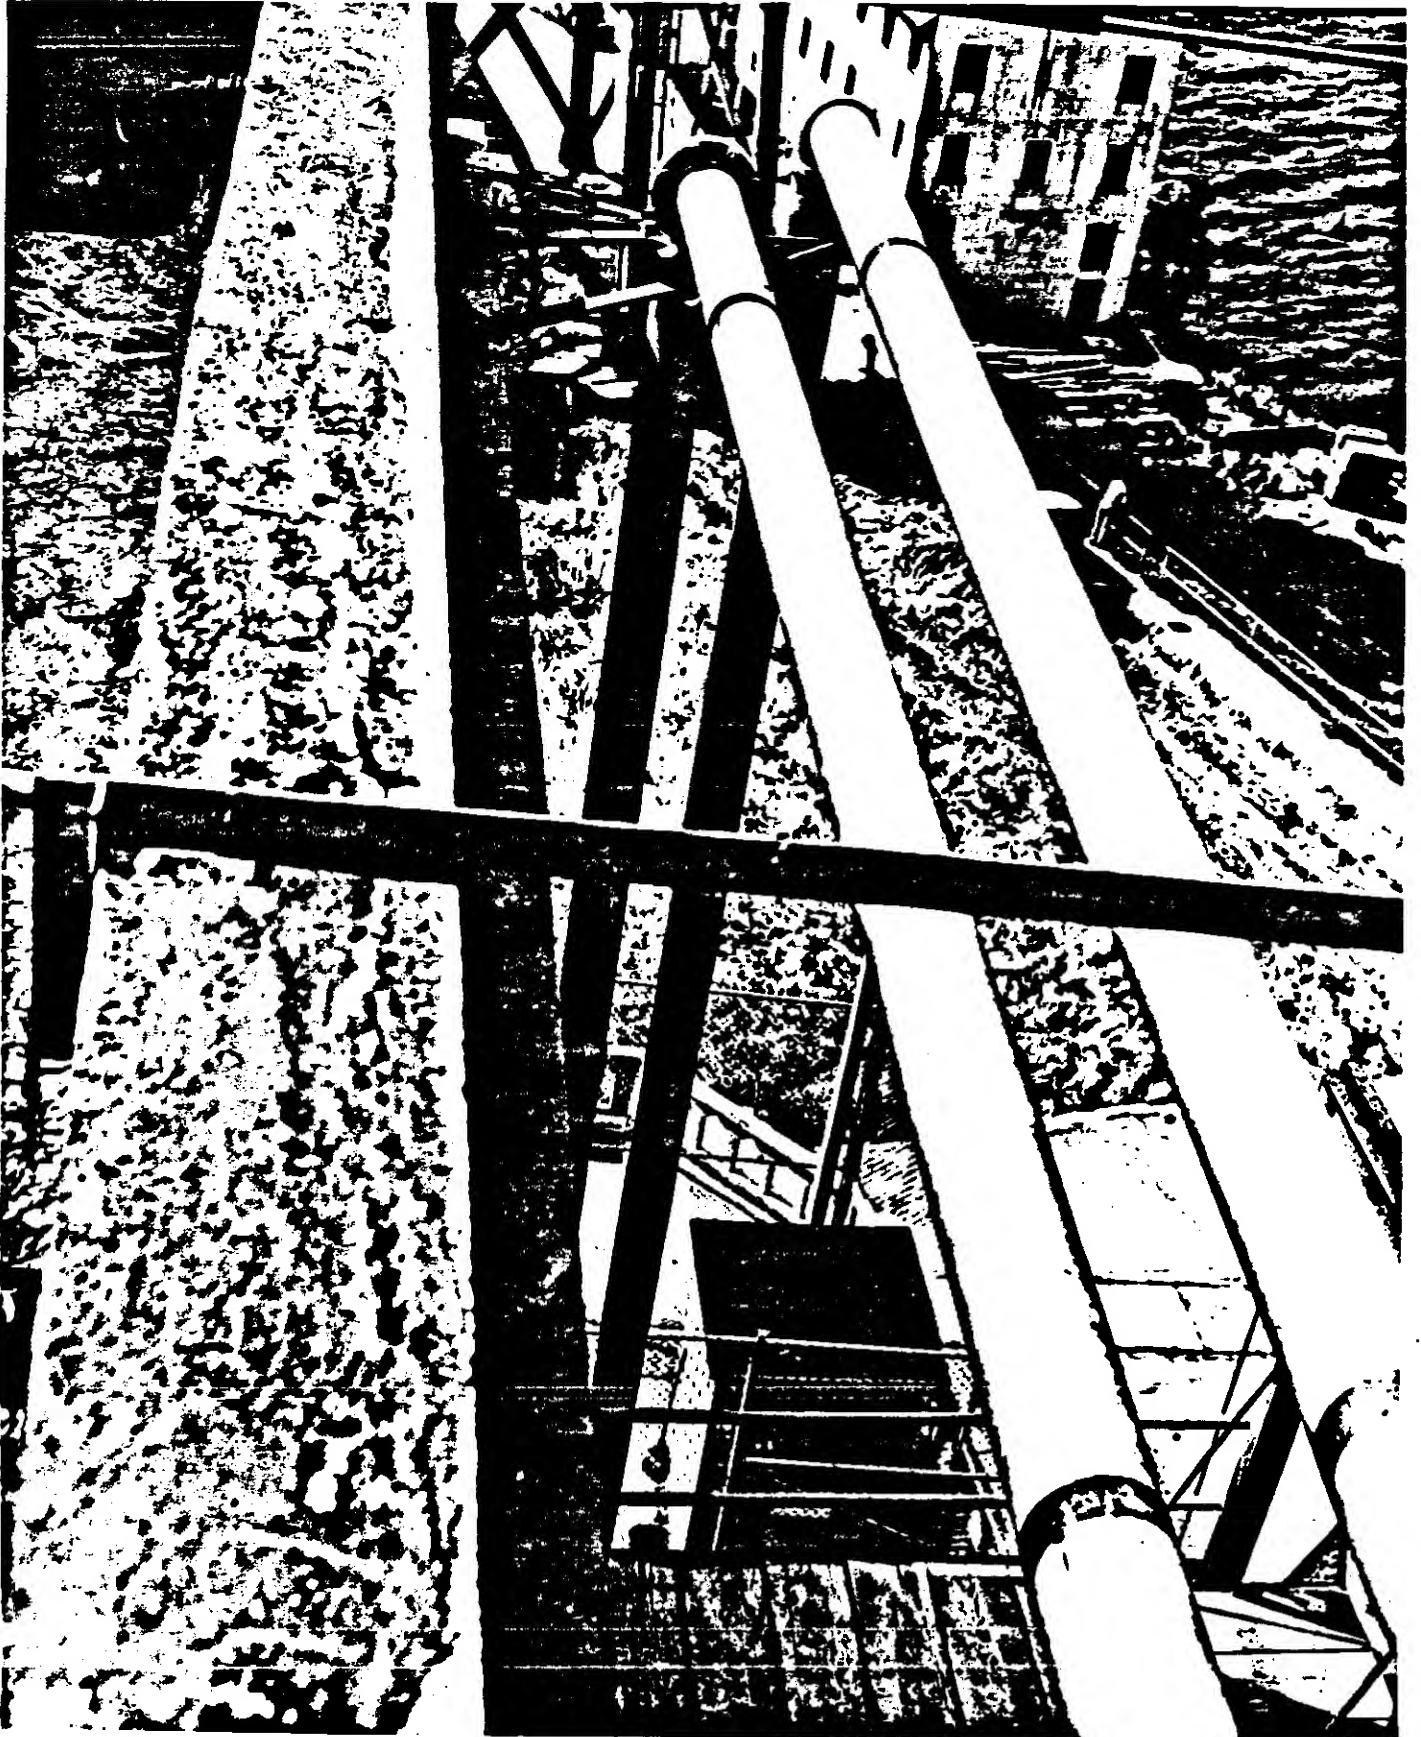
2-11 Photograph taken from roof of building at the northeast corner showing aluminum-plated utility pipes descending to ground level. These pipes are approximately six inches in diameter. Lower center of photograph shows the landing outside of the third floor entrance to the prison building. Stairs lead from this landing to the ground level in the same area as shown in photograph 1-12, however this corner of the building is illuminated by three flood lamps and is clearly visible to the guard in tower number 1 which is manned twenty-four hours a day. The angle iron crossbrace shown in the center of the photograph is the type used to support the illumination. Upper left hand corner shows the type of electrical connection for these lamps.

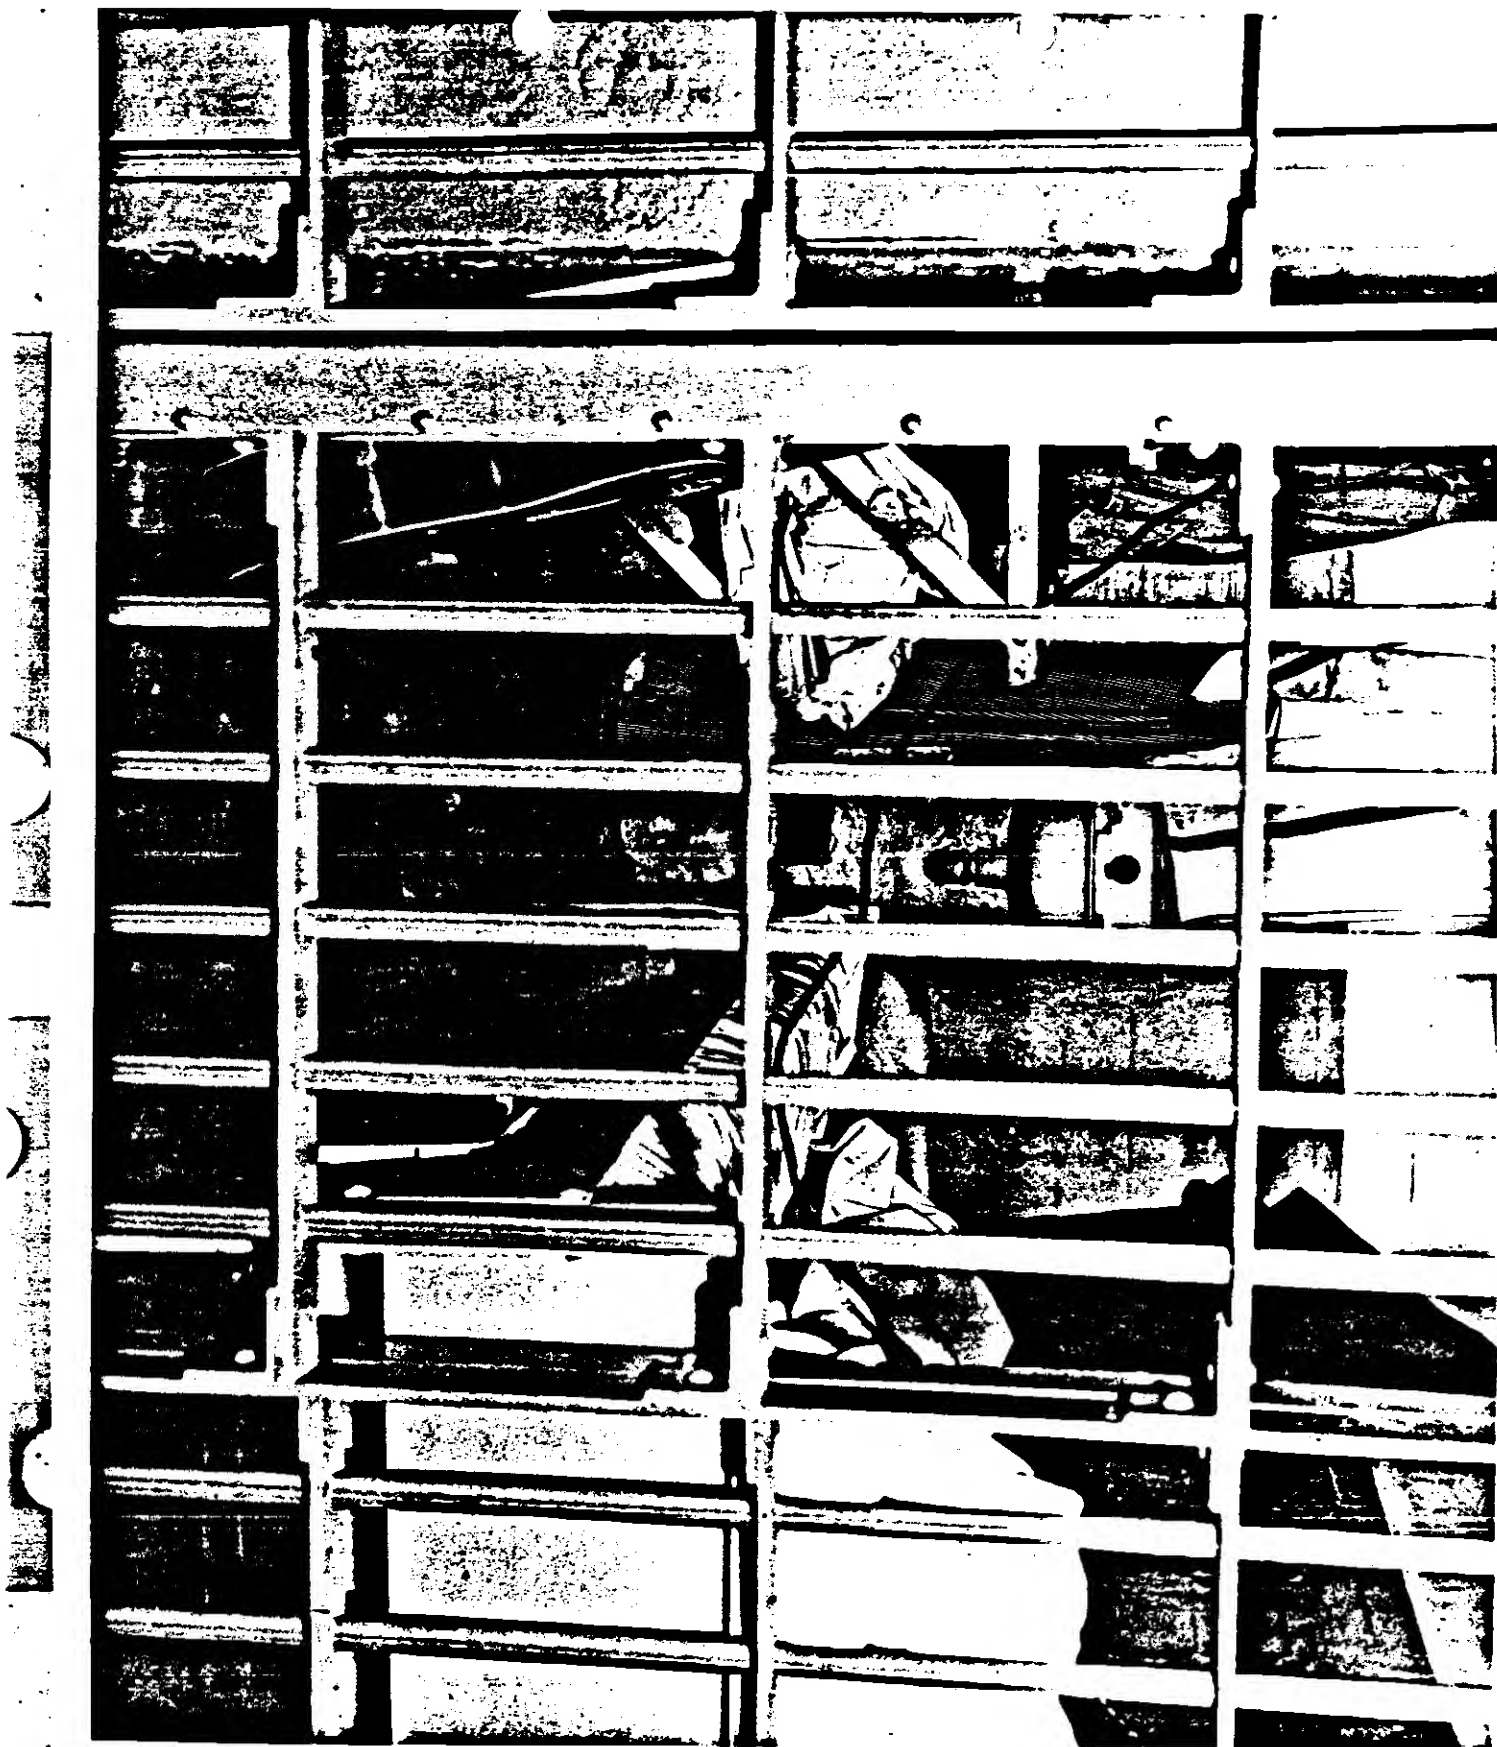
~~3-2~~
3-2

3-2 Photograph of the same cell taken head-on showing the opening at the rear of the cell under the wash basin which permitted Subject CLARENCE ANGLIN to escape. In this photograph the hole is partially covered by a piece of cardboard, the source of which and use of which is unknown.
